## 11.2 Road 1815 Cattle Dip Vat Site, Ozark National Forest, Arkansas

### 11.2.1 Site Description and Conceptual Site Model

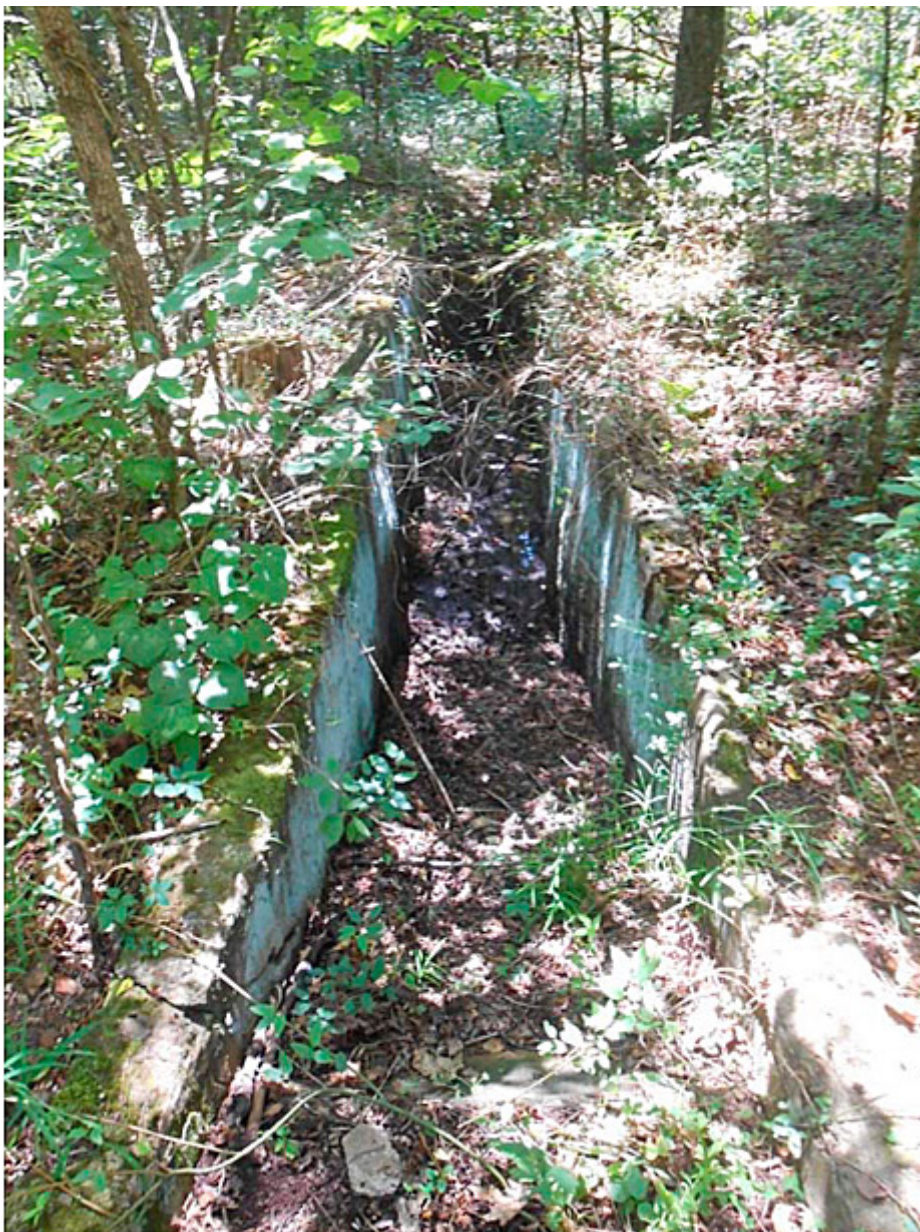
**Figure 11-4. Road 1815 Dip Vat, Ozark National Forest**

The Road 1815 Cattle Dip Vat (CDV) site is located on the toe slope of a large hill just outside the floodplain associated with the North Fork of the Illinois Bayou. The site is located within the Ozark National Forest and is on federally owned land. The concrete vat structure is approximately 31 feet long by 3.5 feet wide by 4 feet deep and is located adjacent to Forest Road 1815, between the road and Sherman Cemetery. Figure 11-4 shows the Road 1815 Dip Vat.
